# COLUMBIA

## ACCIDENT INVESTIGATION BOARD

REPORT VOLUME I  
AUGUST 2003

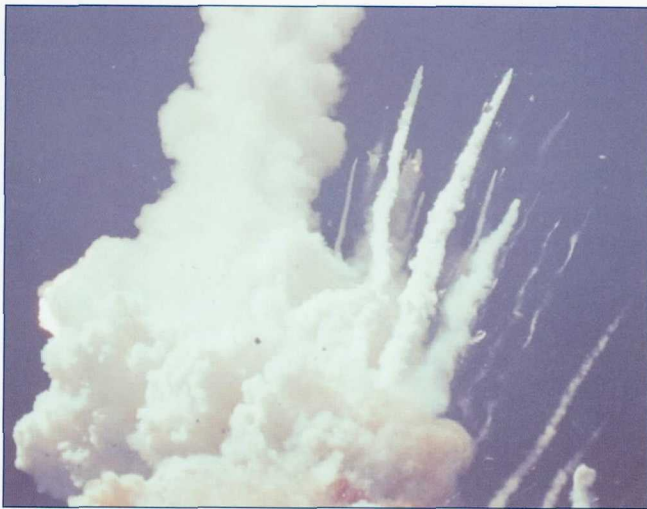
Figure 1.5-1. the Space Shuttle Challenger was lost during ascent on January 28, 1986, when an O-ring and seal in the right Solid Rocket Booster failed.

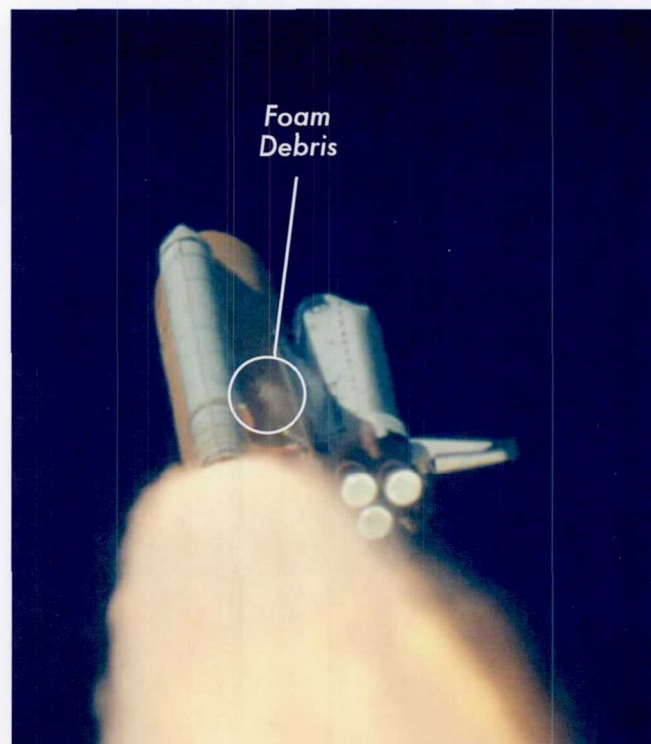
Post-launch photographic analysis showed that one large piece and at least two smaller pieces of insulating foam separated from the External Tank left bipod (-Y) ramp area at 81.7 seconds after launch. Later analysis showed that the larger piece struck *Columbia* on the underside of the left wing, around Reinforced Carbon-Carbon (RCC) panels 5 through 9, at 81.9 seconds after launch (see Figure 2.3-2). Further photographic analysis conducted the day after launch revealed that the large foam piece was approximately 21 to 27 inches long and 12 to 18 inches wide, tumbling at a minimum of 18 times per second, and moving at a relative velocity to the Shuttle Stack of 625 to 840 feet per second (416 to 573 miles per hour) at the time of impact.

Figure 2.3-2. A shower of foam debris after the impact on *Columbia's* left wing. The event was not observed in real time.

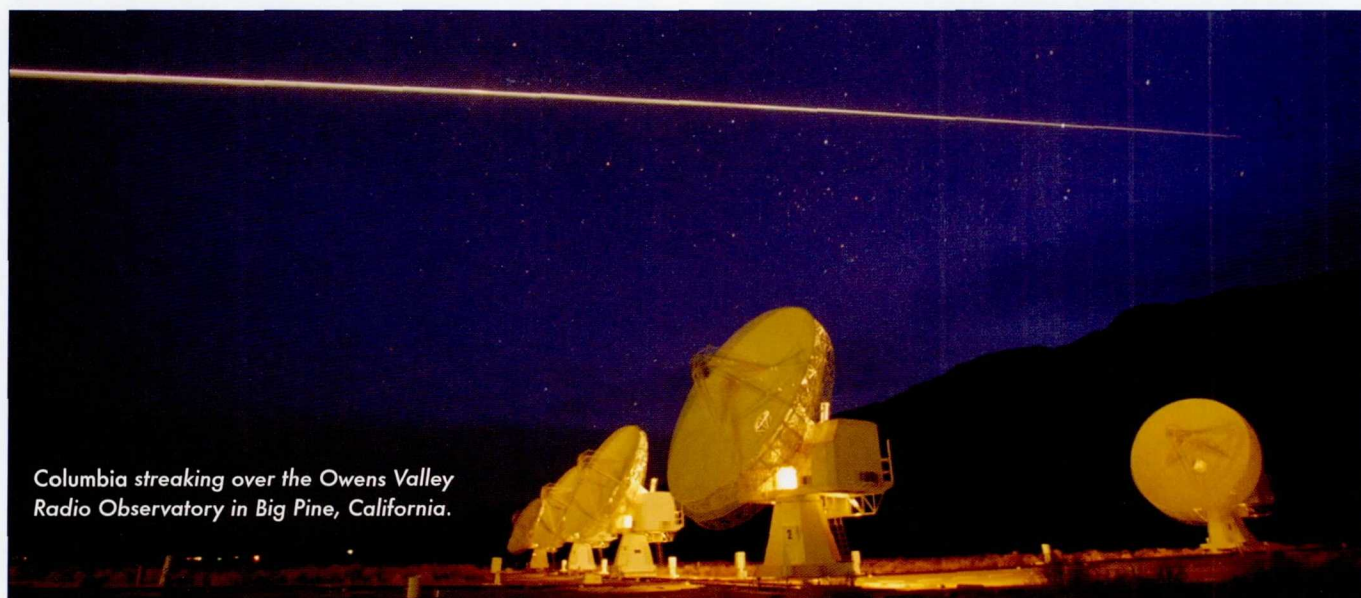
*Columbia streaking over the Owens Valley Radio Observatory in Big Pine, California.*

Now crossing California, the Orbiter appeared to observers on the ground as a bright spot of light moving rapidly across the sky. Signs of debris being shed were sighted at 8:53:46 a.m. (EI+577), when the superheated air surrounding the Orbiter suddenly brightened, causing a noticeable streak in the Orbiter's luminescent trail. Observers witnessed another four similar events during the following 23 seconds, and a bright flash just seconds after *Columbia* crossed from California into Nevada airspace at 8:54:25 a.m. (EI+614), when the Orbiter was traveling at Mach 22.5 and 227,400 feet. Witnesses observed another 18 similar events in the next four minutes as *Columbia* streaked over Utah, Arizona, New Mexico, and Texas.

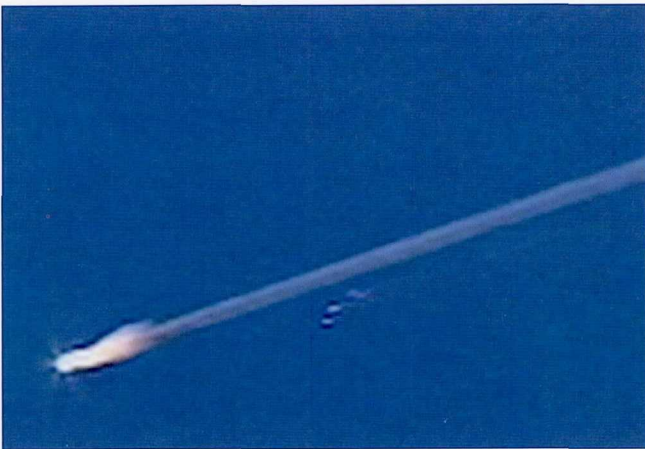
The Orbiter has a large glowing field surrounding it in this view taken from Mesquite, Texas, looking south.

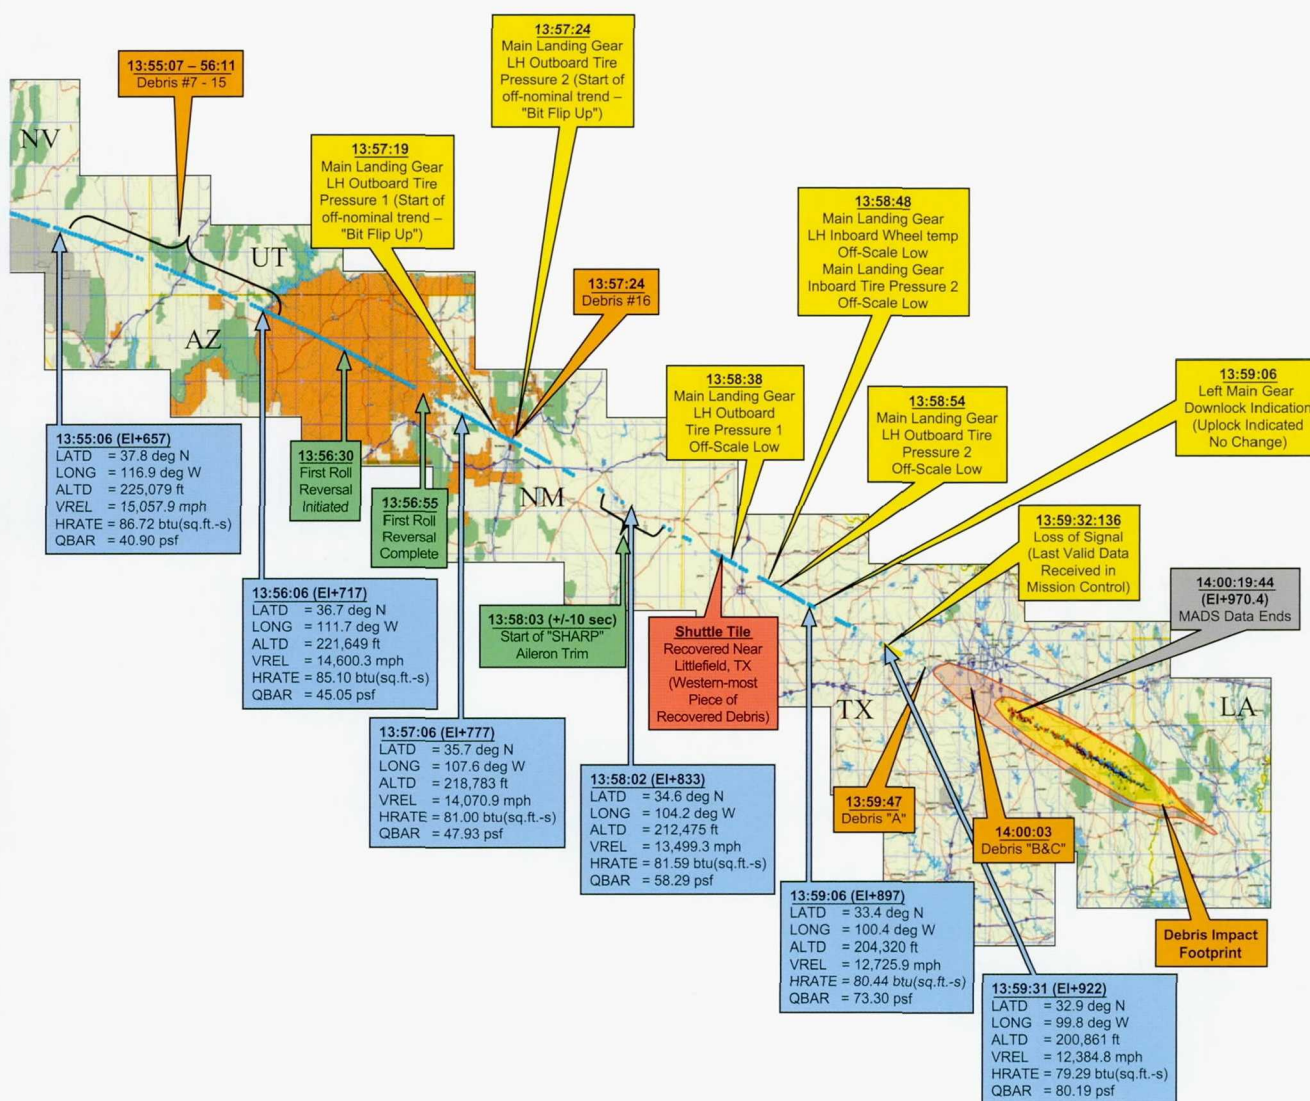
## STS-107 Re-entry Trajectory and Timeline (First Off-Nominal Event to Loss of Signal)

At 8:48:39 a.m. (EI+270), a sensor on the left wing leading edge spar showed strains higher than those seen on previous *Columbia* re-entries. This was recorded only on the Modular Auxiliary Data System, and was not telemetered to ground controllers or displayed to the crew (see Figure 2.6-1).

Figure 2.6-1. This simplified timeline shows the re-entry path of Columbia on February 1, 2003. The information presented here is a composite of sensor data telemetered to the ground combined with data from the Modular Auxiliary Data System recorder recovered after the accident. Note that the first off-nominal reading was a small increase in a strain gauge at the front wing spar behind RCC panel 9-left. The chart is color-coded: blue boxes contain position, attitude, and velocity information; orange boxes indicate when debris was shed from the Orbiter; green boxes are significant aerodynamic control events; gray boxes contain sensor information from the Modular Auxiliary Data System; and yellow boxes contain telemetered sensor information. The red boxes indicate other significant events.

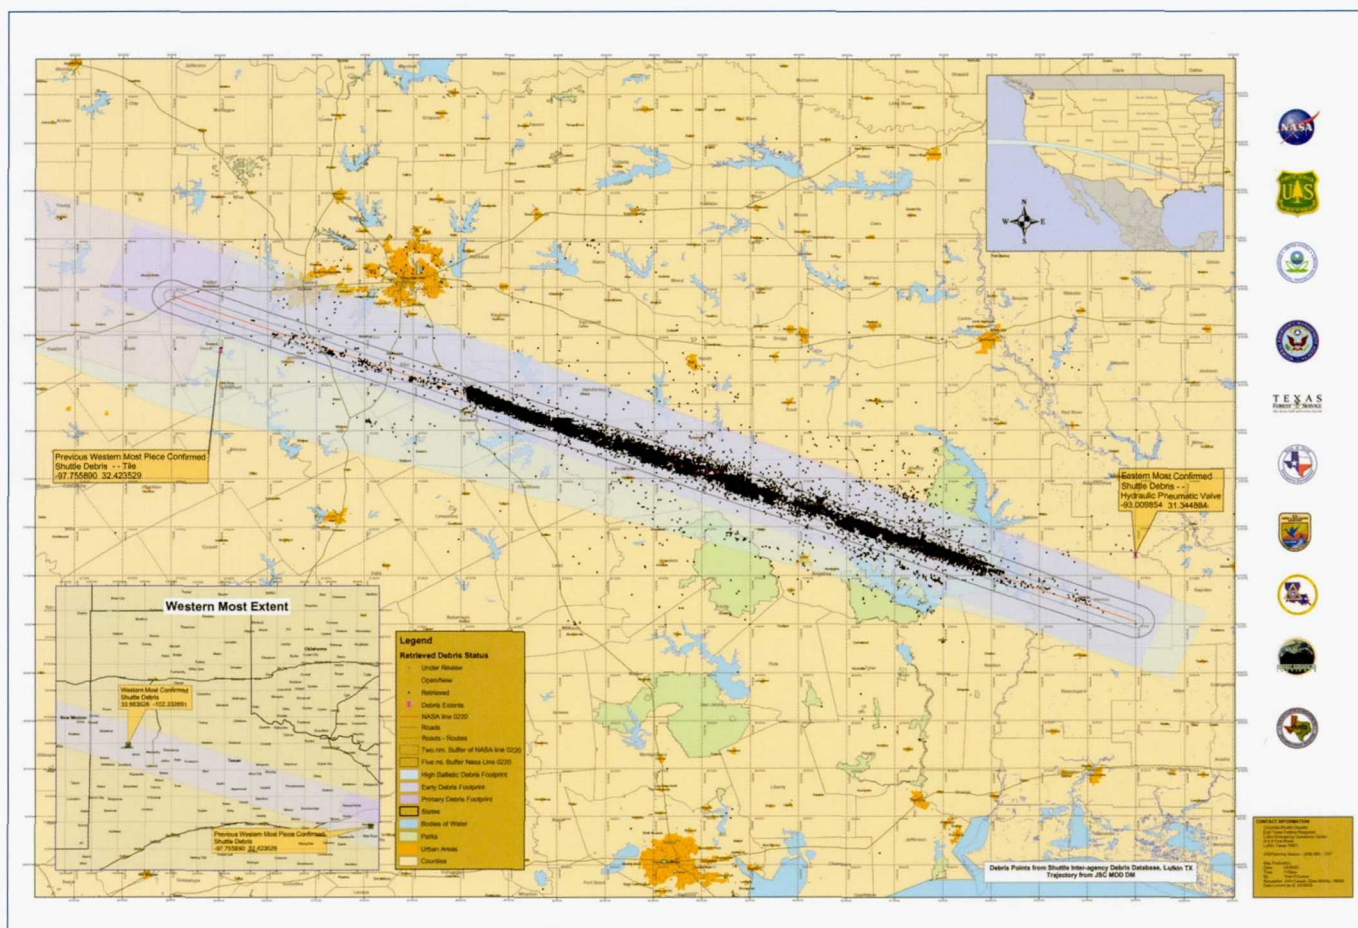
Figure 2.7-1. The debris field in East Texas spread over 2,000 square miles, and eventually over 700,000 acres were searched.

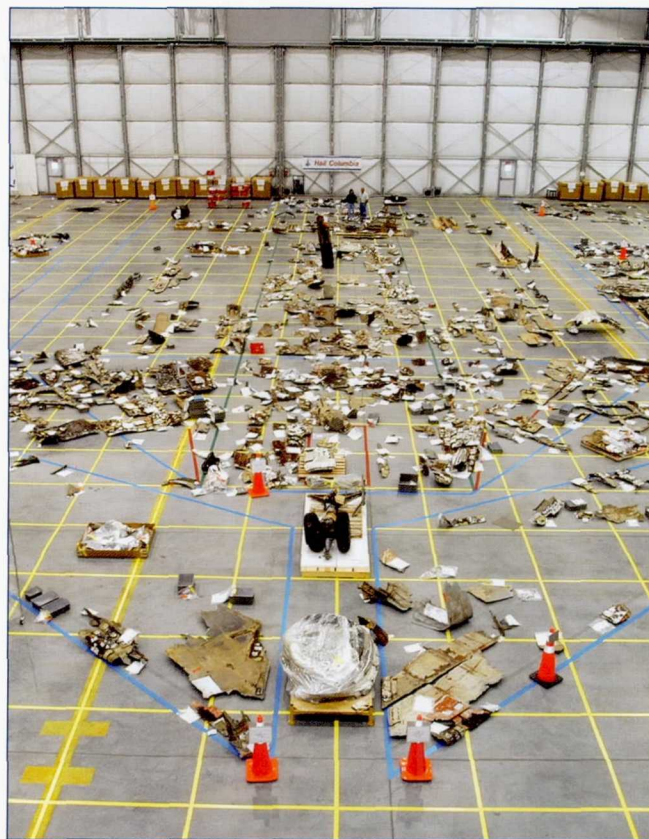
*Figure 2.7-4. Recovered debris was returned to the Kennedy Space Center where it was laid out in a large hangar. The tape on the floor helped workers place each piece near where it had been on the Orbiter.*

The debris collected (see Figure 2.7-4) by searchers aided the investigation in significant ways. Among the most important finds was the Modular Auxiliary Data System recorder that captured data from hundreds of sensors that was not telemetered to Mission Control. Data from these 800 sensors, recorded on 9,400 feet of magnetic tape, provided investigators with millions of data points, including temperature sensor readings from *Columbia's* left wing leading edge. The data also helped fill a 30-second gap in telemetered data and provided an additional 14 seconds of data after the telemetry loss of signal.

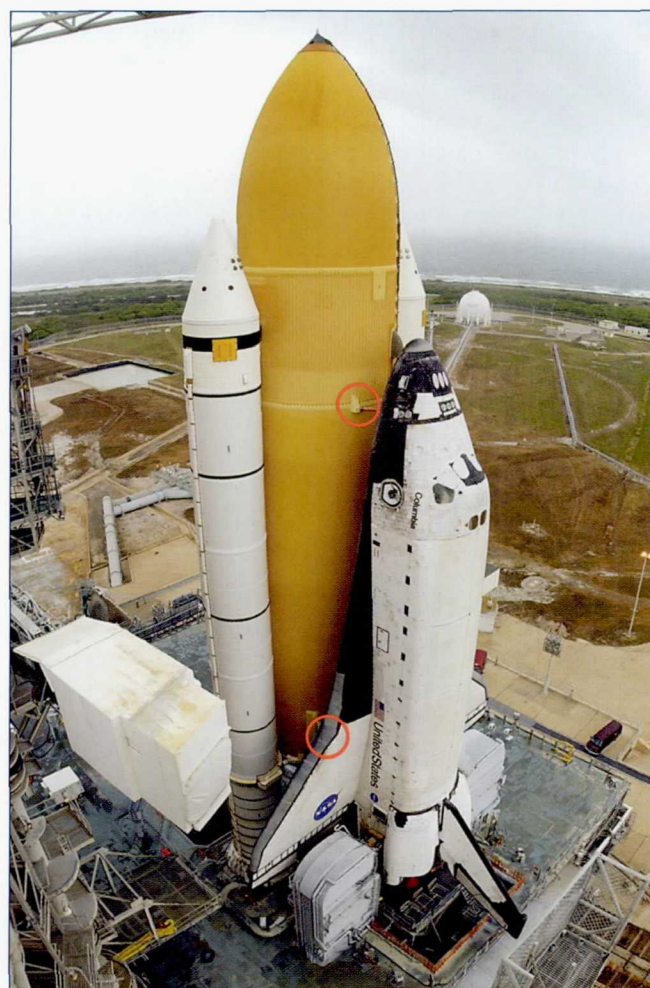
Figure 3.1-1. Columbia sitting at Launch Complex 39-A. The upper circle shows the left bipod (-Y) ramp on the forward attach point, while the lower circle is around RCC panel 8-left.

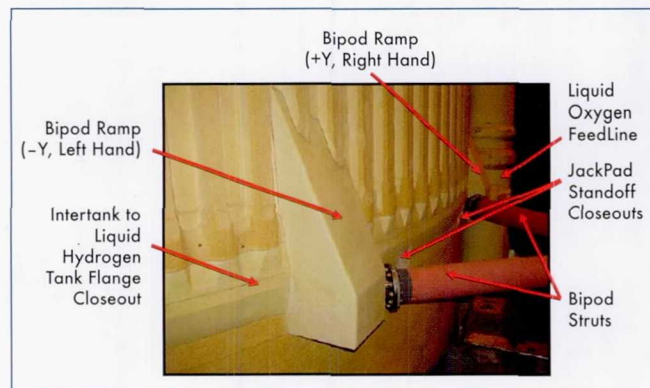
Figure 3.2-2. The exterior of the left bipod attachment area showing the foam ramp that came off during the ascent of STS-107.

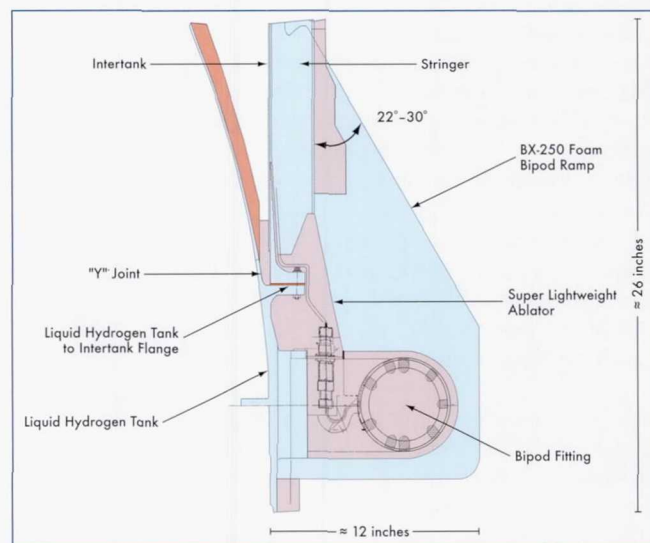
Figure 3.2-3. Cutaway drawing of the bipod ramp and its associated fittings and hardware.

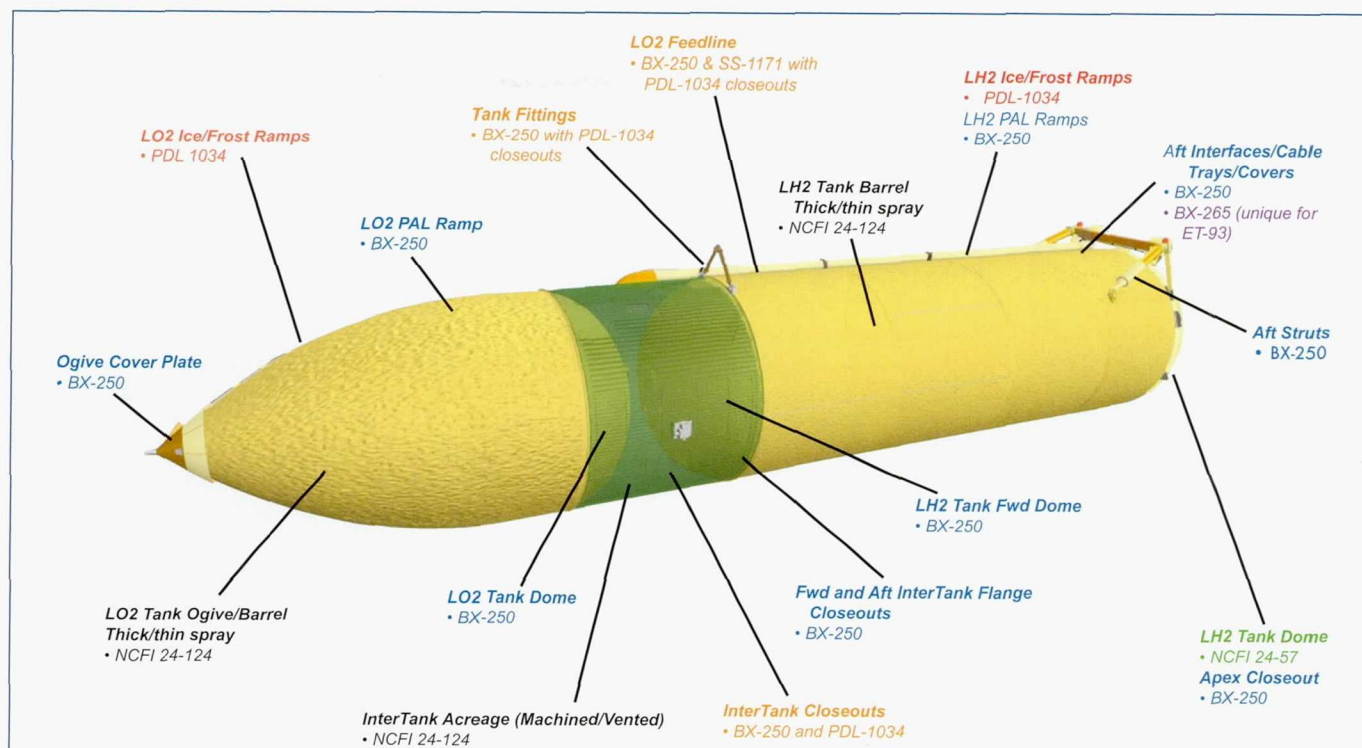
Figure 3.2-4. Locations of the various foam systems as used on ET-93, the External Tank used for STS-107.

oxygen and hydrogen in a liquid state, and to maintain the temperature of external parts high enough to prevent ice and frost from forming on the surface. Figure 3.2-4 summarizes the foam systems used on the External Tank for STS-107.

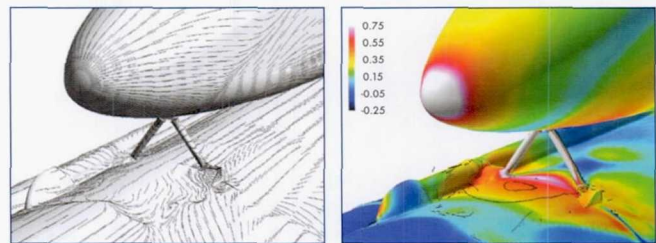
Significant analytical advancements have been made since the External Tank was first conceived, particularly in computational fluid dynamics (see Figure 3.2-5). Computational fluid dynamics comprises a computer-generated model that represents a system or device and uses fluid-flow physics and software to create predictions of flow behavior, and stress or deformation of solid structures. However, analysis must always be verified by test and/or flight data. The External Tank and the bipod ramp were not tested in the complex flight environment, nor were fully instrumented External Tanks ever launched to gather data for verifying analytical tools. The accuracy of the analytical tools used to simulate the External Tank and bipod ramp were verified only by using flight and test data from other Space Shuttle regions.

Figure 3.2-5. Computational Fluid Dynamics was used to understand the complex flow fields and pressure coefficients around bipod strut. The flight conditions shown here approximate those present when the left bipod foam ramp was lost from External Tank 93 at Mach 2.46 at a 2.08-degree angle of attack.

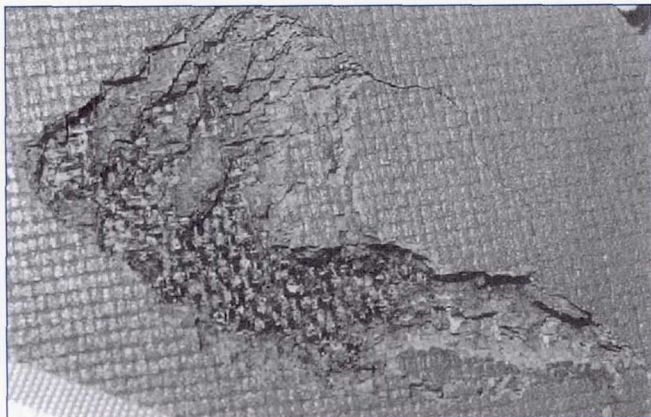
Figure 3.3-2. Damage on the outer surface of RCC panel 10-right from *Atlantis* after STS-45.

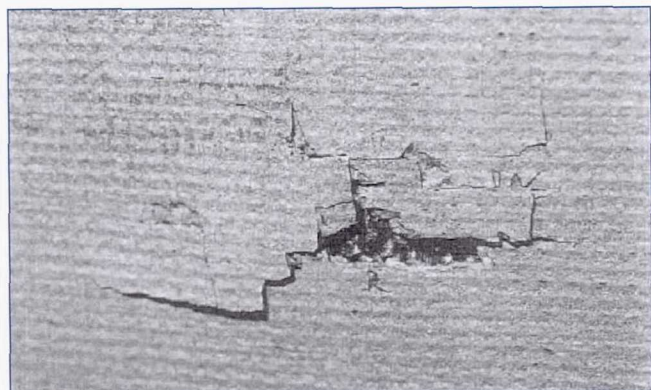
RCC components have been struck by objects throughout their operational life, but none of these components has been completely penetrated. A sampling of 21 post-flight reports noted 43 hypervelocity impacts, the largest being 0.2 inch. The most significant low-velocity impact was to *Atlantis*' panel 10-right during STS-45 in March and April 1992. The damaged area was 1.9 inches by 1.6 inches on the exterior surface and 0.5 inches by 0.1 inches in the interior surface. The substrate was exposed and oxidized, and the panel was scrapped. Analysis concluded that the damage was caused by a strike by a man-made object, possibly during ascent. Figures 3.3-2 and 3.3-3 show the damage to the outer and inner surfaces, respectively.

Figure 3.3-3. Damage on the inner surface of RCC panel 10-right from *Atlantis* after STS-45.

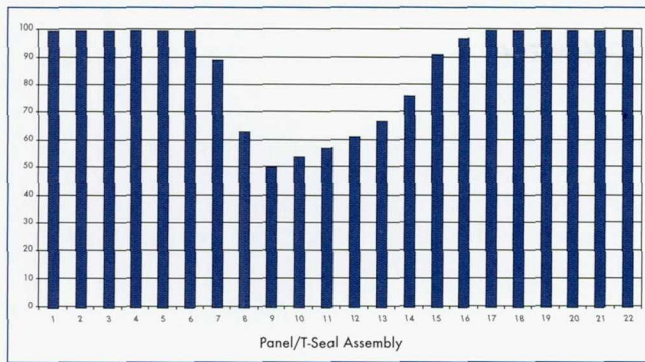
For the first five missions of *Columbia*, the RCC components were not coated with Type A sealant, and had shorter mission service lives than the RCC components on the other Orbiters. (*Columbia*'s panel 9 has the shortest mission service life of 50 flights as shown in Figure 3.3-4.) The predicted life for panel/T-seals 7 through 16 range from 54 to 97 flights.<sup>7</sup>

Figure 3.3-4. The expected mission life for each of the wing leading edge RCC panels on Columbia. Note that panel 9 has the shortest life expectancy.

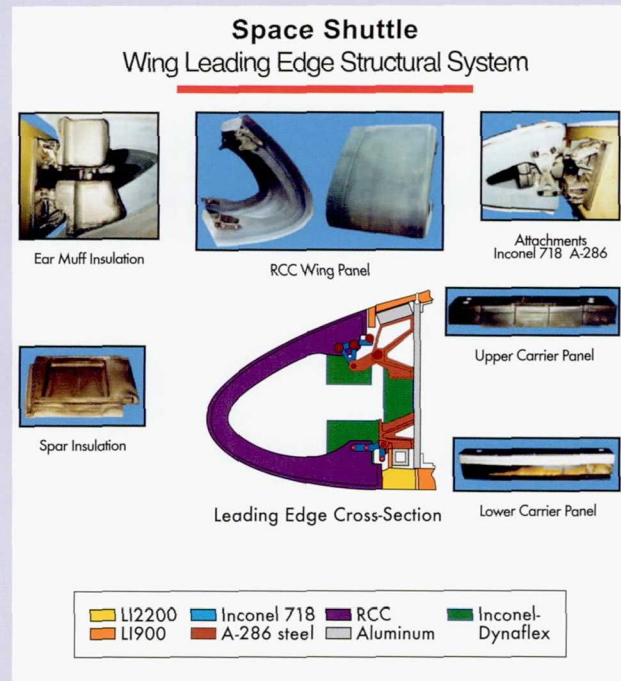
The mid-wing area on the left wing, behind where the breach occurred, is supported by a series of trusses, as shown in red in the figure below. The mid-wing area is bounded in the front and back by the Xo1040 and Xo1191 cross spars, respectively. The numerical designation of each spar comes from its location along the Orbiter's X-axis; for example, the Xo1040 spar is 1,040 inches from the zero point on the X-axis. The cross spars provide the wing's structural integrity. Three major cross spars behind the Xo1191 spar provide the primary structural strength for the aft portion of the wing. The inboard portion of the mid-wing is the outer wall of the left wheel-well, and the outboard portion of the mid-wing is the wing leading edge spar, where the RCC panels attach.

The Wing Leading Edge Structural System on Columbia.

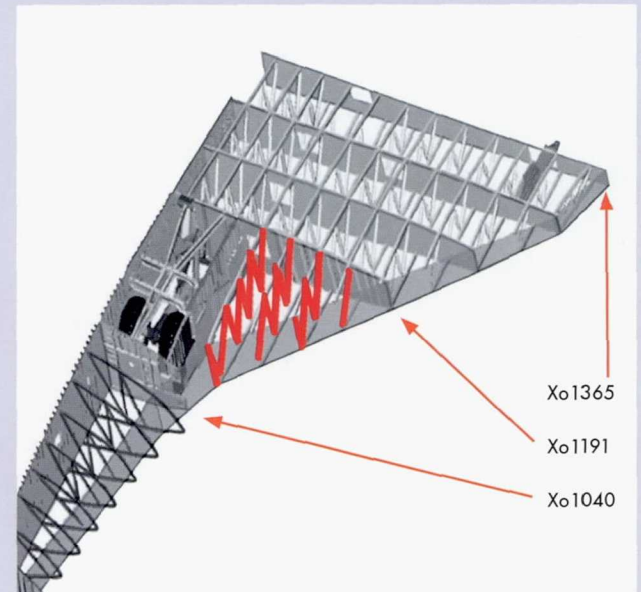
The major internal support structures in the mid-wing are constructed from aluminum alloy. Since aluminum melts at 1,200 degrees Fahrenheit, it is likely these truss tubes in the mid-wing were destroyed and wing structural integrity was lost.

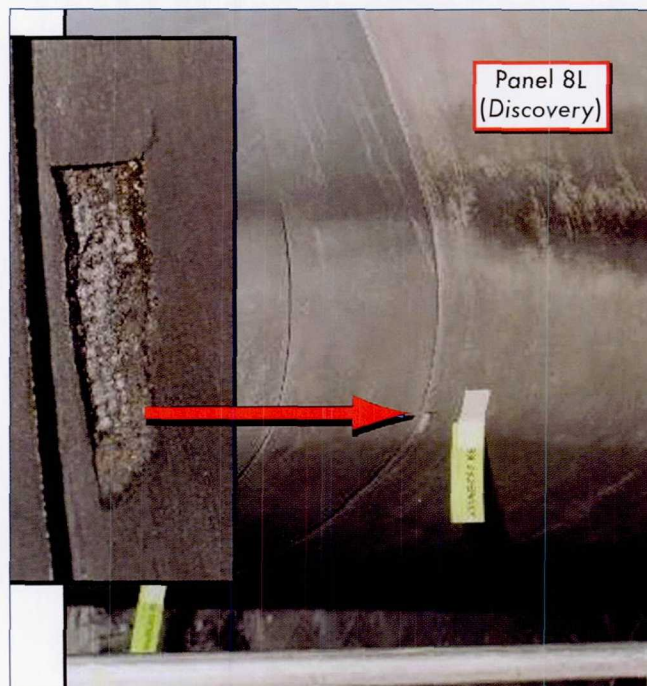
Figure 3.3-5. RCC panel 8-left from *Discovery* had to be scrapped after STS-103 because of the damage shown here.

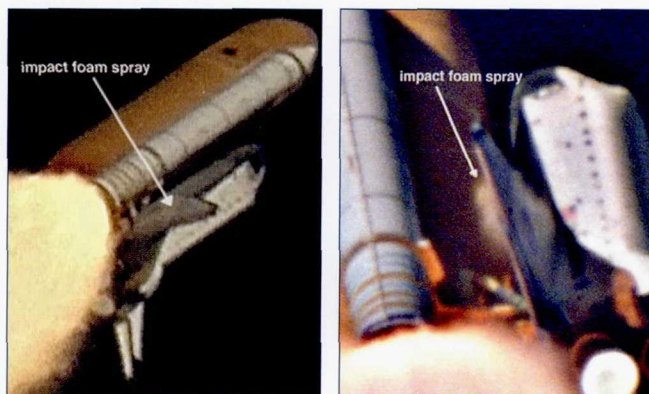
Figure 3.4-1 (color enhanced and "de-blurred" by Lockheed Martin Gaithersburg) and Figure 3.4-2 (processed by the National Imagery and Mapping Agency) are samples of the type of visual data used to establish the time of the impact (81.9 seconds), the altitude at which it occurred (65,860 feet), and the object's relative velocity at impact (about 545 mph relative to the Orbiter).

A 35-mm film camera, E212, which recorded the foam strike from 17 miles away, and video camera E208, which recorded it from 26 miles away, provided the best of the available evidence. Analysis of this visual evidence (see Figures 3.4-1 and 3.4-2) along with computer-aided design analysis, refined the potential impact area to less than 20 square feet in RCC panels 6 through 9 (see Figure 3.4-3), including a portion of the corresponding carrier panels and adjacent tiles. The investigation image analysis team found no conclusive visual evidence of post-impact debris flowing over the top of the wing.

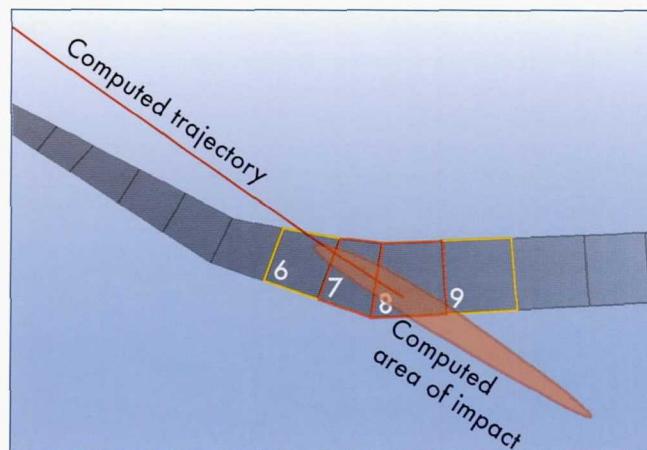
Figure 3.4-3: The best estimate of the site of impact by the center of the foam.

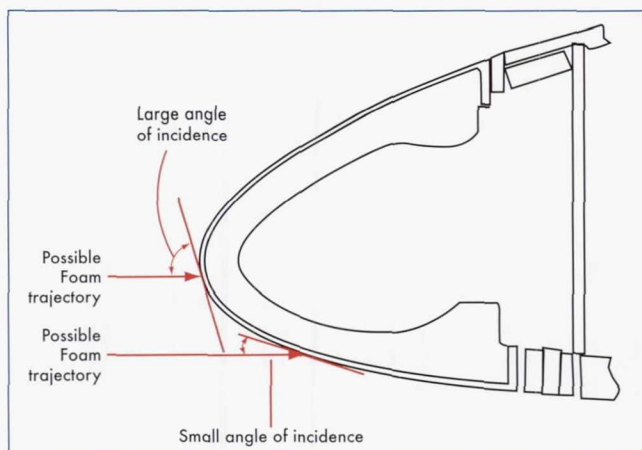
Image analysis determined that the foam was moving almost parallel to the Orbiter's fuselage at impact, with about a five-degree angle upward toward the bottom of the wing and slight motion in the outboard direction. If the foam had hit the tiles adjacent to the leading edge, the angle of incidence would have been about five degrees (the angle of incidence is the angle between the relative velocity of the projectile and the plane of the impacted surface). Because the wing leading edge curves, the angle of incidence increases as the point of impact approaches the apex of an RCC panel. Image and transport analyses estimated that for impact on RCC panel 8, the angle of incidence was between 10 and 20 degrees (see Figure 3.4-4).<sup>9</sup> Because the total force delivered by the impact depends on the angle of incidence, a foam strike near the apex of an RCC panel could have delivered about twice the force as an impact close to the base of the panel.

Figure 3.4-4. This drawing shows the curve of the wing leading edge and illustrates the difference the angle of incidence has on the effect of the foam strike.

The precise impact location of the foam determined the impact angle because the debris was moving almost parallel to the Orbiter's fuselage at impact. Tile areas would have been hit at very small angles (approximately five degrees), but the curvature of the leading edge created angles closer to 20 degrees (see Figure 3.4-4).

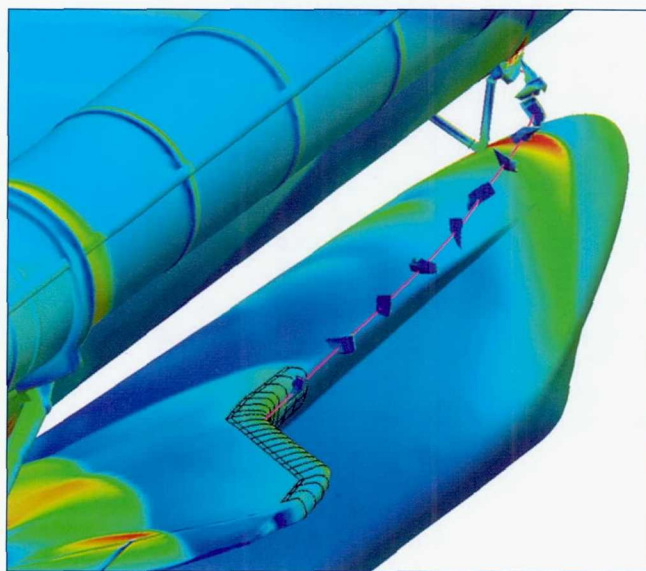
Figure 3.4-6. These are the results of a trajectory analysis that used a computational fluid dynamics approach in a program called CART-3D, a comprehensive (six-degree-of-freedom) computer simulation based on the laws of physics. This analysis used the aerodynamic and mass properties of bipod ramp foam, coupled with the complex flow field during ascent, to determine the likely position and velocity histories of the foam.

The undetermined and yet certainly irregular shape of the foam introduced substantial uncertainty about its estimated aerodynamic characteristics. Appendix D.8 contains an independent analysis conducted by the Board to confirm that the estimated range of ballistic coefficients of the foam in Figure 3.4-6 was credible, given the foam dimension results from the image analyses and the expected range of the foam density. Based on the results in Figure 3.4-7, the physical dimensions of the bipod ramp, and the sizes and shapes of the available barrels for the compressed-gas gun used in the impact test program described later in this chapter, the Board and the NASA Accident Investigation Team decided that a foam projectile 19 inches by 11.5 inches by 5.5 inches, weighing 1.67 pounds, and with a weight density of 2.4 pounds per cubic foot, would best represent the piece of foam that separated from the External Tank bipod ramp and was hit by the Orbiter's left wing. See Section 3.8 for a full discussion of the foam impact testing.

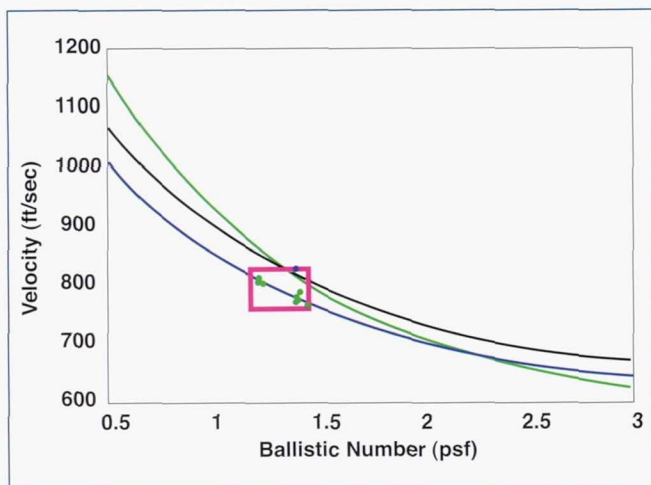
Figure 3.4-7. The results of numerous possible trajectories based on various assumed sizes, shapes, and densities of the foam. Either the foam had a slightly higher ballistic coefficient and the Orbiter struck the foam at a lower speed relative to the Orbiter, or the foam was more compact and the wing struck the foam at a higher speed. The "best fit" box represents the overlay of the data from the image analysis with the transport analysis computations. This data enabled a final selection of projectile characteristics for impact testing.

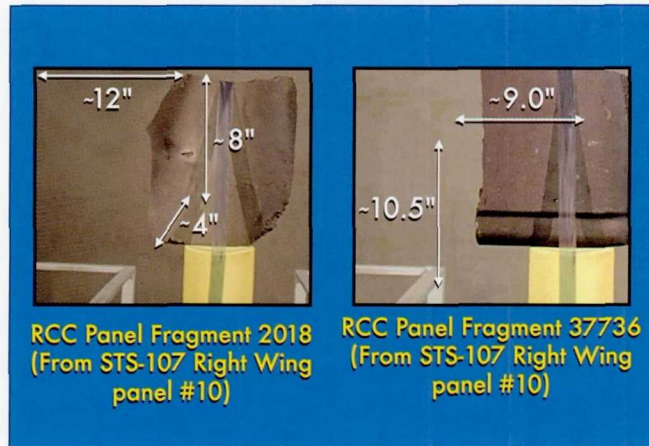
Figure 3.5-1. These representative RCC acreage pieces matched the radar cross-section of the Flight Day 2 object.

In the Advanced Compact Range at the Air Force Research Laboratory in Dayton, Ohio, analysts tested 31 materials from the Orbiter's exterior and payload bay. Additional supercomputer radar cross-section predictions were made for Reinforced Carbon-Carbon T-seals. After exhaustive radar cross-section analysis and testing, coupled with ballistic analysis of the object's orbital decay, only a fragment of RCC panel would match the UHF radar cross-section and ballistic coefficients observed by the Space Surveillance network. Such an RCC panel fragment must be approximately 140 square inches or greater in area to meet the observed radar cross-section characteristics. Figure 3.5-1 shows RCC panel fragments from *Columbia*'s right wing that represent those meeting the observed characteristics of object 2003-003B.<sup>10</sup>

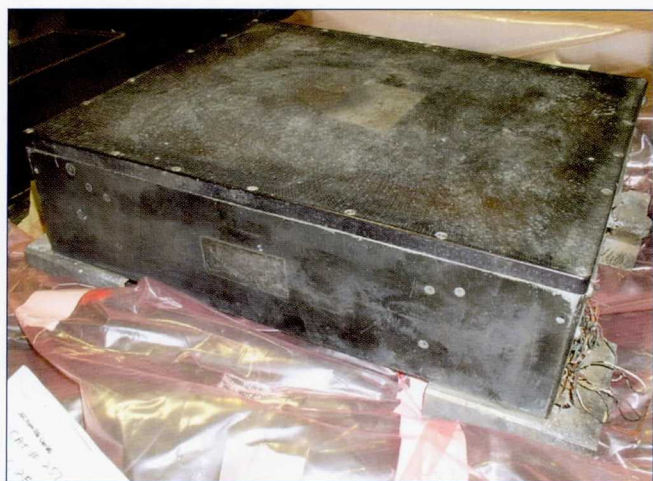
The Modular Auxiliary Data System is a supplemental instrumentation system that gathers Orbiter data for processing after the mission is completed. Inputs are almost exclusively physical sensor readings of temperatures, pressures, mechanical strains, accelerations, and vibrations. The Modular Auxiliary Data System usually records only the mission's first and last two hours (see Figure 3.6-1).

Figure 3.6-1. The Modular Auxiliary Data System recorder, found near Hemphill, Texas. While not designed to withstand impact damage, the recorder was in near-perfect condition when recovered on March 19, 2003.

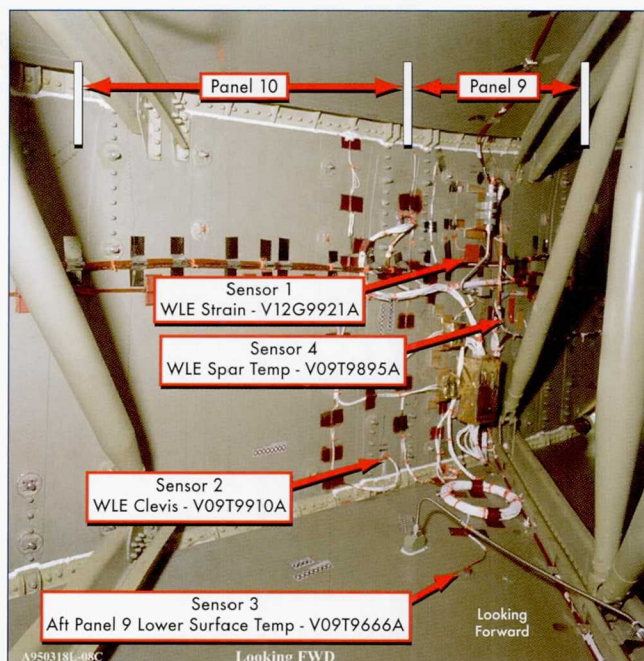
Figure 3.6-2. Location of sensors on the back of the left wing leading edge spar (vertical aluminum structure in picture). Also shown are the round truss tubes and ribs that provided the structural support for the mid-wing in this area.

or outside the wing leading edge spar near Reinforced Carbon-Carbon (RCC) panel 9-left, helped tell the story of what happened on the left wing of the Orbiter early in the re-entry. These four sensors were: strain gauge V12G9921A (Sensor 1), resistance temperature detector V09T9910A on the RCC clevis between panel 9 and 10 (Sensor 2), thermocouple V07T9666A, within a Thermal Protection System tile (Sensor 3), and resistance temperature detector V09T9895A (Sensor 4), located on the back side of the wing leading edge spar behind RCC panels 8 and 9 (see Figure 3.6-2).

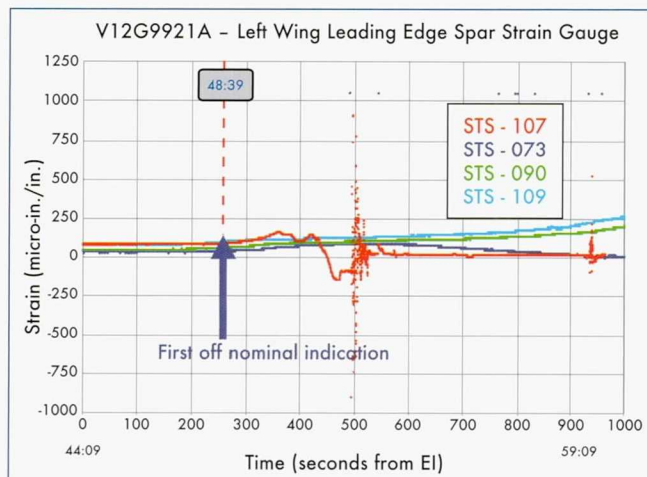
Figure 3.6-3. The strain gauge (Sensor 1) on the back of the left wing leading edge spar was the first sensor to show an anomalous reading. In this chart, and the others that follow, the red line indicates data from STS-107. Data from other *Columbia* re-entries, similar to the STS-107 re-entry profile, are shown in the other colors.

Sensor 1 provided the first anomalous reading (see Figure 3.6-3). From EI+270 to EI+360, the strain is higher than that on previous *Columbia* flights. At EI+450, the strain reverses, and then peaks again in a negative direction at EI+475. The strain then drops slightly, and remains constant and negative until EI+495, when the sensor pattern becomes unreliable, probably due to a propagating soft short, or “burn-through” of the insulation between cable conductors caused by heating or combustion. This strain likely indicates significant damage to the aluminum honeycomb spar. In particular, strain reversals, which are unusual, likely mean there was significant high-temperature damage to the spar during this time.

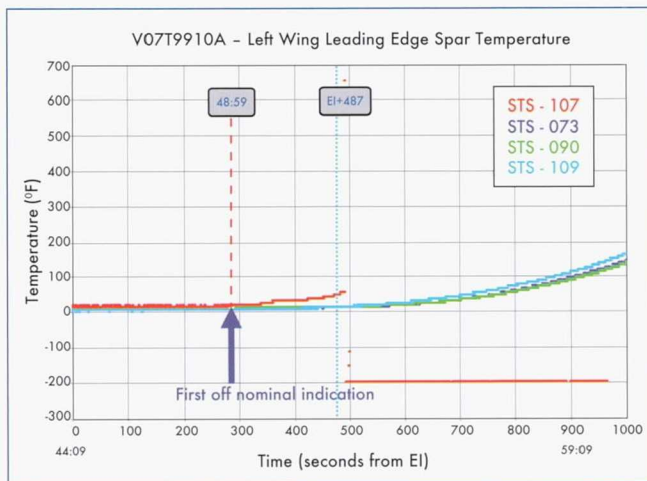
Figure 3.6-4. This temperature thermocouple (Sensor 2) was mounted on the outside of the wing leading edge spar behind the insulation that protects the spar from radiated heat from the RCC panels. It clearly showed an off-nominal trend early in the re-entry sequence and began to show an increase in temperature much earlier than the temperature sensor behind the spar.

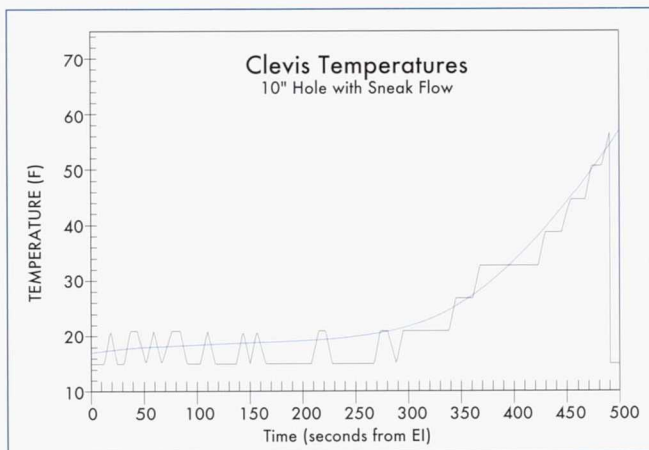
A series of thermal analyses were performed for different sized holes in RCC panel 8 to compute the time required to heat Sensor 2 to the temperature recorded by the Modular Auxiliary Data System. To heat the clevis, various insulators would have to be bypassed with a small amount of leakage, or “sneak flow.” Figure 3.6-5 shows the results of these calculations for, as an example, a 10-inch hole, and demonstrates that with sneak flow around the insulation, the temperature profile of the clevis sensor was closely matched by the engineering calculations. This is consistent with the same sneak flow required to match a similar but abnormal ascent temperature rise of the same sensor, which further supports the premise that the breach in the leading edge of the wing occurred during ascent. While the exact size of the breach will never be known, and may have been smaller or larger than 10 inches, these analyses do provide a plausible explanation for the observed rises in temperature sensor data during re-entry.

Figure 3.6-5. The analysis of the effect of a 10-inch hole in RCC panel 8 on Sensor 2 from EI to EI+500 seconds. The jagged line shows the actual flight data readings and the smooth line the calculated result for a 10-inch hole with some sneak flow of superheated air behind the spar insulation.

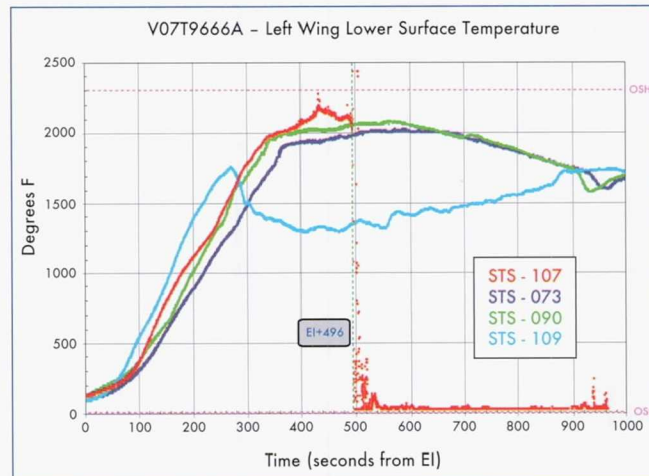
Figure 3.6-6. As early as EI+370, Sensor 3 began reading significantly higher than on previous flights. Since this sensor was located in a thermal tile on the lower surface of the left wing, its temperatures are much higher than those for the other sensors.

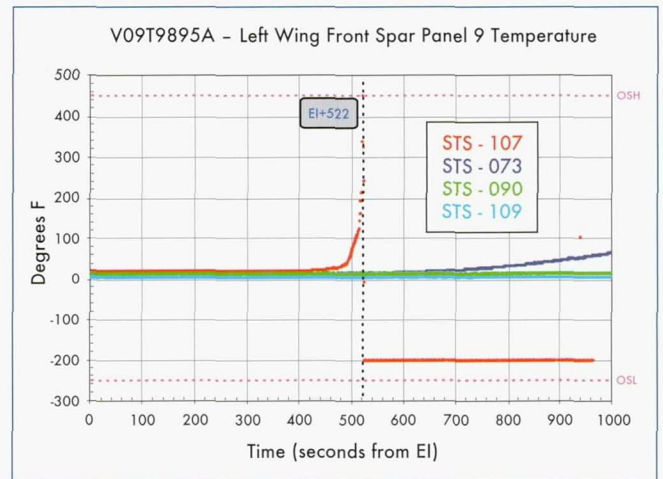
Figure 3.6-7. Sensor 4 also began reading significantly higher than previous flights before it fell off-scale low. The relatively late reaction of this sensor compared to Sensor 2, clearly indicated that superheated air started on the outside of the wing leading edge spar and then moved into the mid-wing after the spar was burned through. Note that immediately before the sensor (or the wire) fails, the temperature is at 450 degrees Fahrenheit and climbing rapidly. It was the only temperature sensor that showed this pattern.

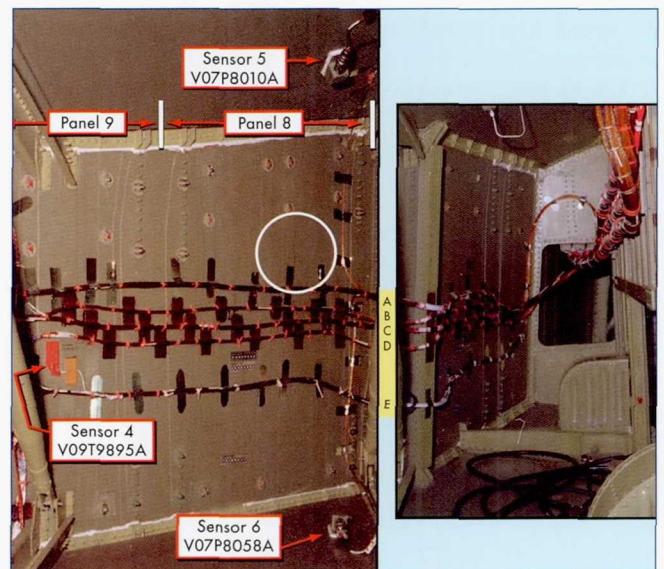
Figure 3.6-8. The left photo above shows the wiring runs on the backside of the wing leading edge behind RCC panel 8 – the circle marks the most likely area where the burn through of the wing leading edge spar initially occurred at EI+487 seconds. The right photo shows the wire bundles as they continue forward behind RCC panels 7 and 6. The major cable bundles in the upper right of the right photo carried the majority of the sensor data inside the wing. As these bundles were burned, controllers on the ground began seeing off-nominal sensor indications.

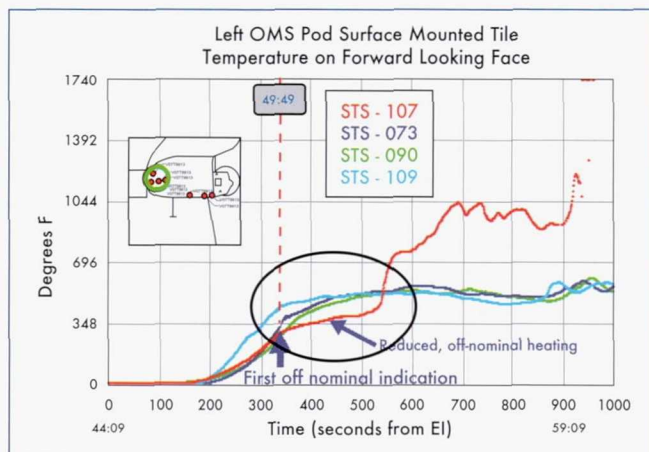
Figure 3.6-9. Orbital Maneuvering System (OMS) pod heating was initially significantly lower than that seen on previous Columbia missions. As wing leading edge damage later increased, the OMS pod heating increased dramatically. Debris recovered from this area of the OMS pod showed substantial pre-breakup heat damage and imbedded drops of once-molten metal from the wing leading edge in the OMS pod thermal tiles.

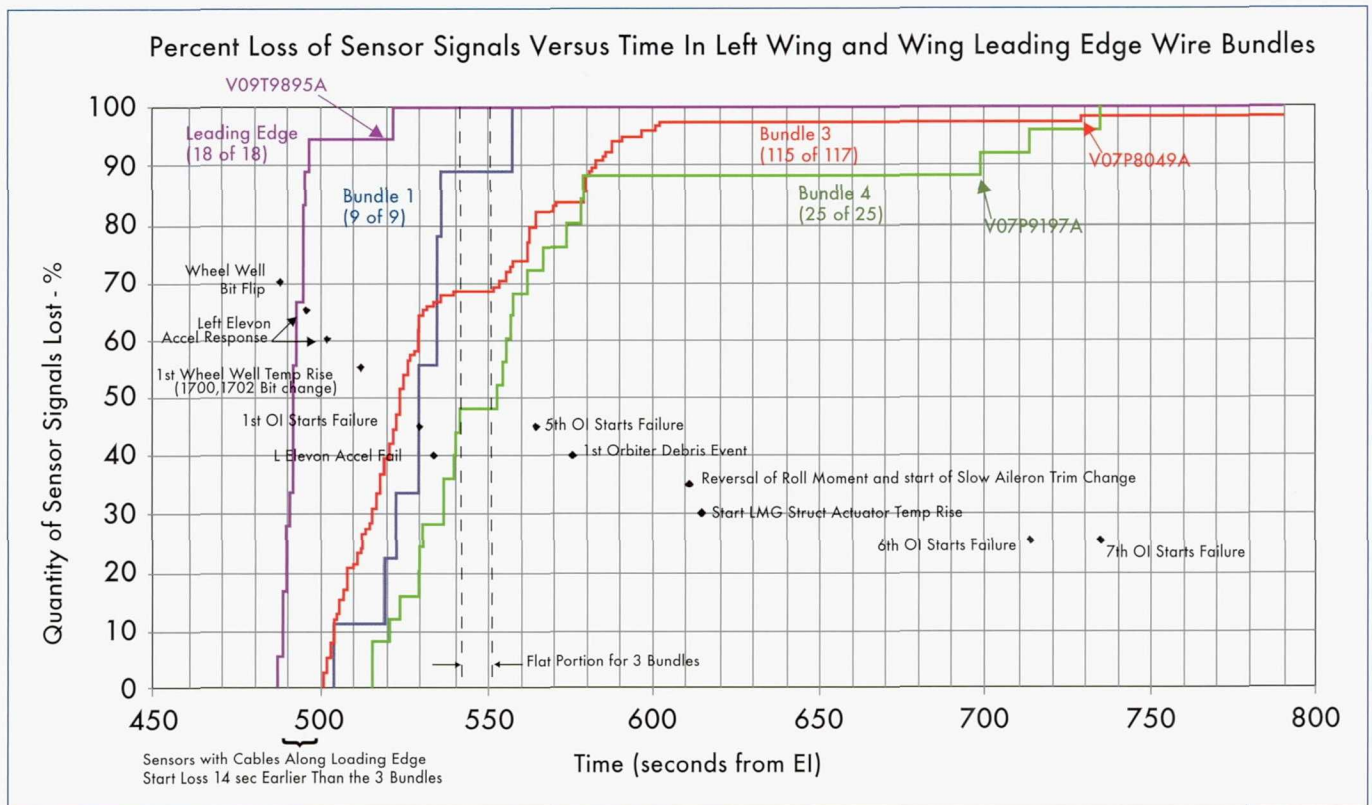
Fourteen seconds after the loss of the first sensor wire on the wing leading edge spar at EI+487, a sensor wire in a bundle of some 150 wires that ran along the upper outside corner of the left wheel well showed a burn-through. In the next 50 seconds, more than 70 percent of the sensor wires in three cables in this area also burned through (see Figure 3.6-10). Investigators plotted the wiring run for every left-wing sensor, looking for a relationship between their location and time of failure.

Figure 3.6-10. This chart shows how rapidly the wire bundles in the left wing were destroyed. Over 70 percent of the sensor wires in the wiring bundles burned through in under a minute. The black diamonds show the times of significant timeline sensor events.

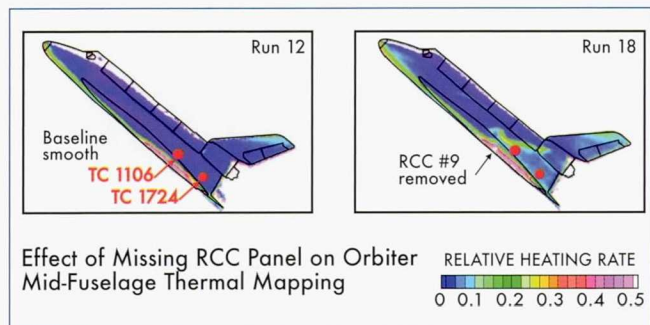
Figure 3.6-13. The effects of removing RCC panel 9 are shown in this figure. Note the brighter colors on the front of the OMS pod show increased heating, a phenomenon supported by both the OMS pod temperature sensors and the debris analysis.

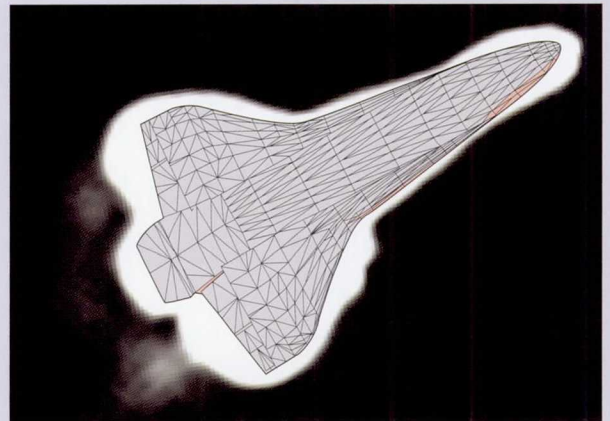
The image shows an unusual condition on the left wing, a leading-edge disturbance that might indicate damage. Several analysts concluded that the distortion evident in the image likely came from the modification and interaction of shock waves due to the damaged leading edge. The overall appearance of the leading-edge damage at this point on the trajectory is consistent with the scenario.
